MITSUBISHI MOTOR SALES OF AMERICA, Inc.

TECHNICAL SERVICE BULLETIN

AXLE DRIVE PINION TOOL — SERVICE MANUAL CORRECTION

NO.	TSB-91-27-004
DATE	February, 1991
MODEL	1988-91 Montero, Truck

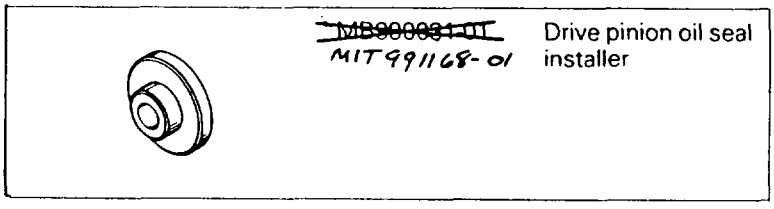
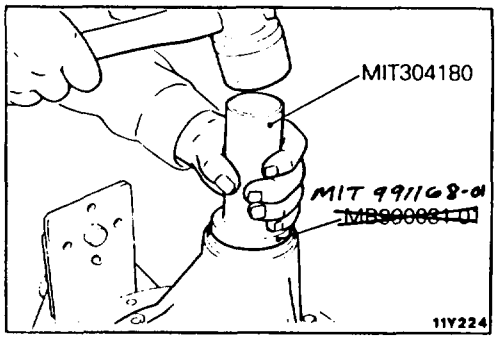
The Differential Seal Installer tool number, shown in the service manuals as MB990031-01, is incorrect. The correct tool number is **MB991168-01**.

~~MB990031-01~~ MIT991168-01 Drive pinion oil seal installer

The handle tool number, MIT304180, is correct.
